RE: Building Enclosure Assessment
7217 Riverside Drive, Grand Forks, BC

RJC No. KEL.117050.0001

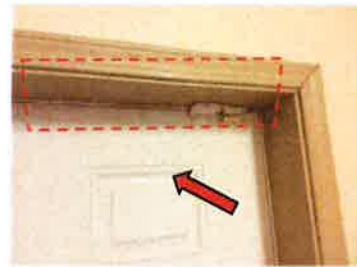
While completing site observations for a separate roof condition assessment for Whispers of Hope on October 13, 2016, RJC observed water entering the interior space of the south addition at the east elevation along the door head (Photo 1 & 2). The leak above this door is puzzling as there is an awning present above the door. This would indicate that the leak is likely originating from the top of the roof and travels down through the wall system. Once the water reaches the door head, the water will take the path of least resistance which, in this case, is through the door frame.

Photo 1 - Water ingress along door head at west door

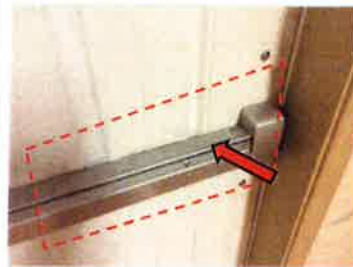
Photo 2 - Water accumulation along door exit mechanism

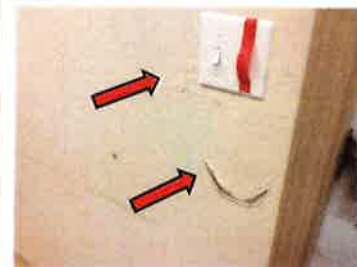
Further review showed that there was also damage which appeared to be caused by water ingress at the south addition at the west elevation adjacent to the door. Paint was sagging under the electrical outlet and

the drywall was swelling in the surrounding areas (Photo 3). Again, due to this leaks proximity with the door, it is likely that the leak originates at the roof level and travels down through the wall system. In this case, it appears that once the water hits the door head, it diverts to the door jambs and continues downward which has caused the water damaged directly adjacent to the door frame.

Photo 3 - Damage to interior drywall at east door

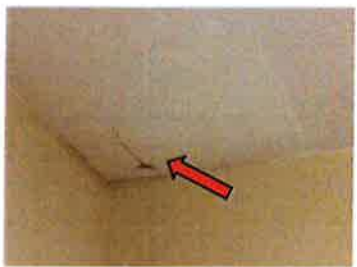
During our review of the roof assembly on both October 13, 2016 and December 8, 2016, there were active leaks present through the south addition roof. These leaks were present at the south-west corner in the living room (Photo 4) and in the shelter rooms (Photo 5 & 6). The wood strapping (Photo 6) was in place prior to our review on October 13, 2016 indicating that these leak has been active for a prolonged period of time.

Photo 4 - Damage to ceiling drywall in living room area

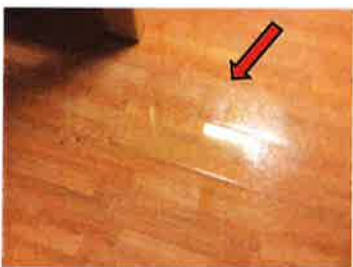
Photo 5 - Puddle of water forming on room floor

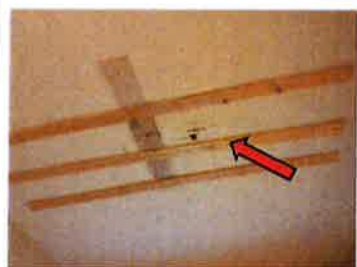
Photo 6 - Damage to ceiling drywall in shelter room

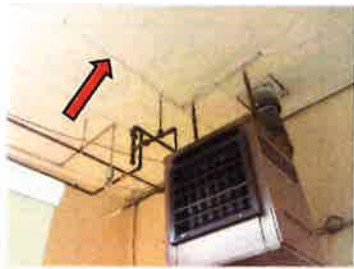
From discussions with site personnel and further observations throughout the building, it appears that leaks through the roof assembly have been ongoing on central building (Photo 7) and the south addition (Photo 8). The central building roof was over-clad with a thin-gauge metal roof in an attempt to address active leaks through the existing roof membrane (Photo 9).

<p>Photo 7 - Damage to ceiling drywall at central building</p>	<p>Photo 8 – patch to roof on south addition</p>	<p>Photo 9 – Overcladding of roof system on central building</p>
